# Hope Vale Aboriginal Shire Council

## Drinking Water Quality Management Plan

September 2020

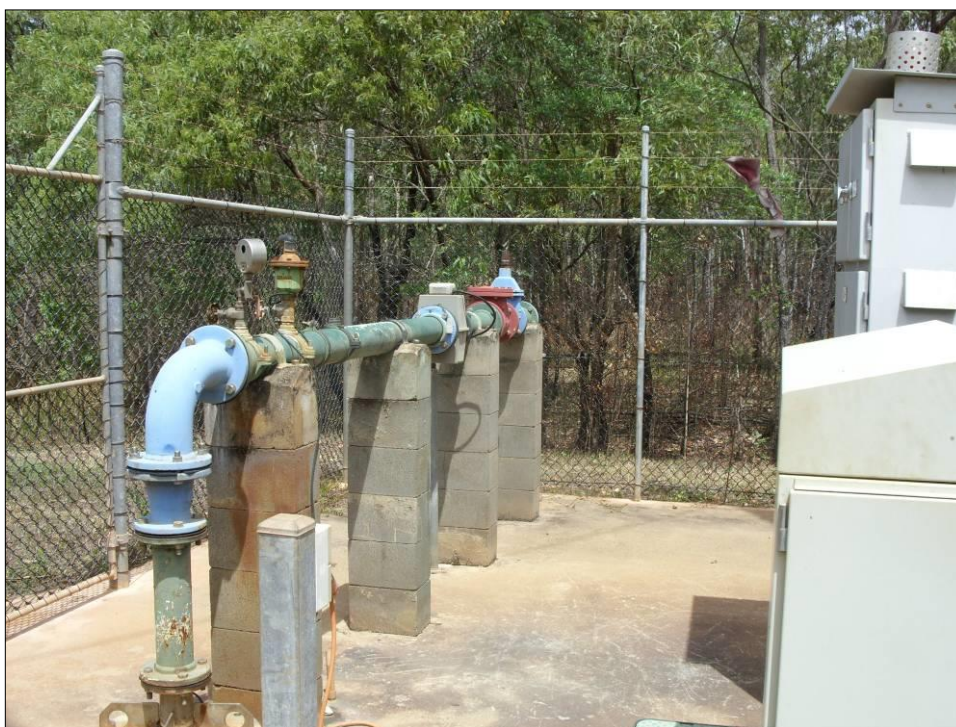
Picture of GA1 showing the raised bore head, concrete slab and fencing.

Pump operation is controlled through SCADA in response to water levels in the Clear Water Tank.

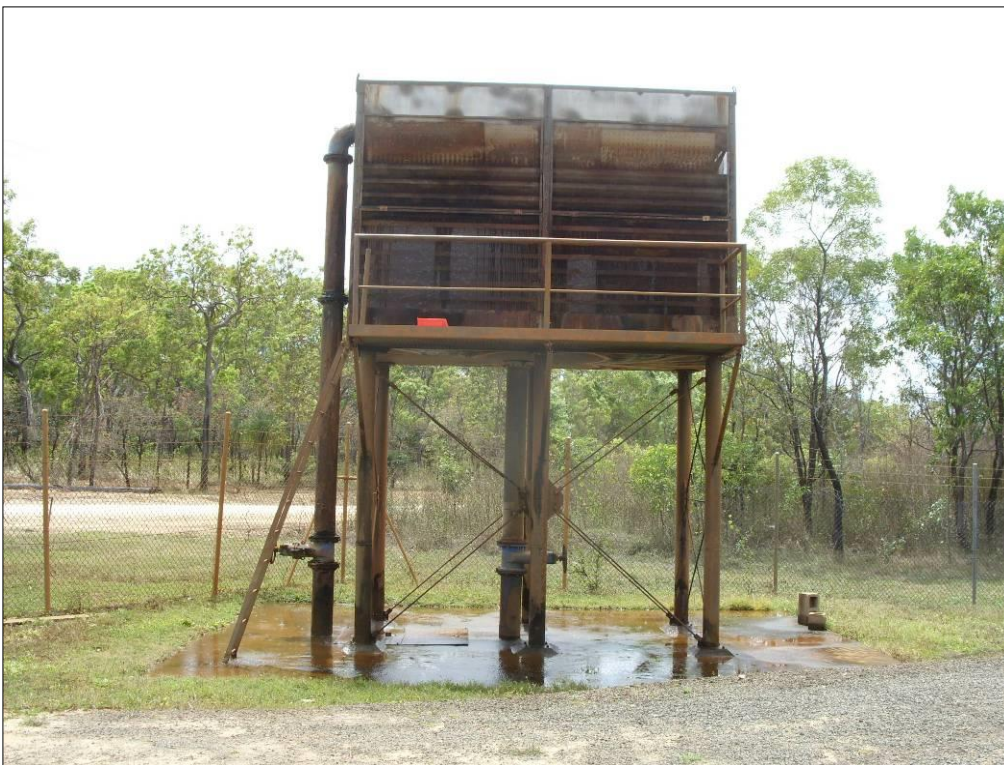
Picture showing the aerator used for iron control.

| Bypass / variation | The aerator has bypass ability. It is used when the aerator is offline due to cleaning. |

The main water supply undergoes the full aeration treatment process whereas the back up supply is only chlorinated. By-passing chlorination is not possible.

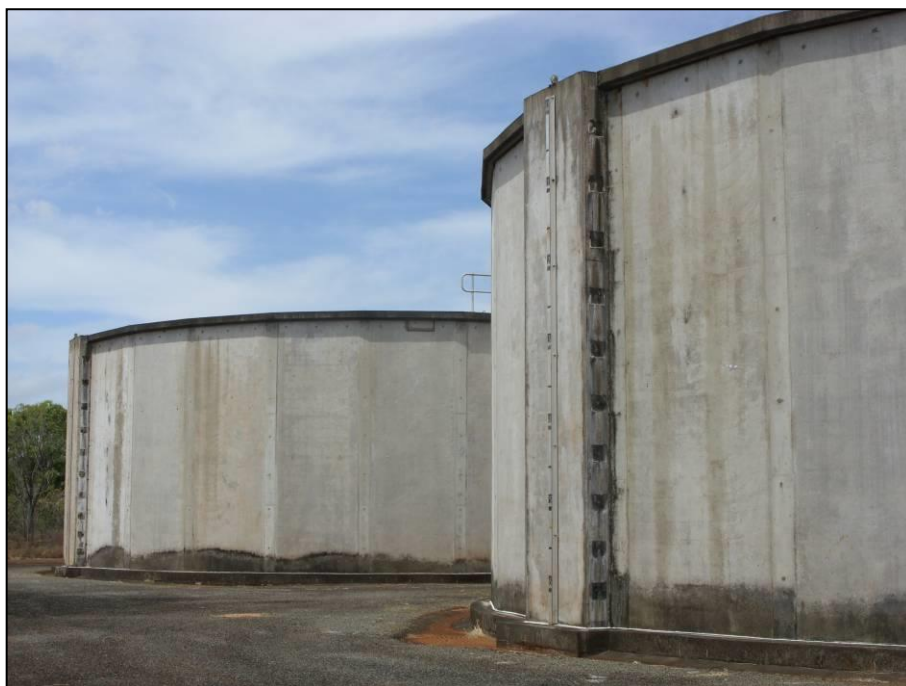
Picture showing the two reservoirs.

| Filling | Controlled through SCADA (automatic). When level is low, the clear water tank pumps are activated. |
